Management Report

Kubota Tractor Corp - Southeastern Division
Kubota Tractor Corp - Southeastern Division - Main Bldg
1025 Northbrook Parkway, Suwanee, GA

Prepared For
Kubota

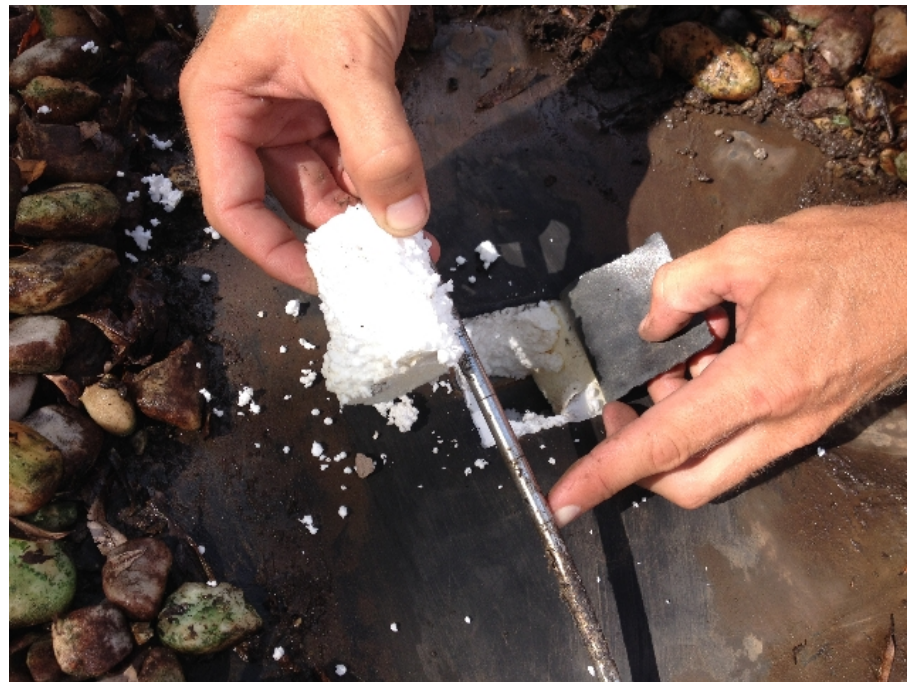
Test Cut 1

EPDM - Ballasted
2.5" EPS
Metal Decking

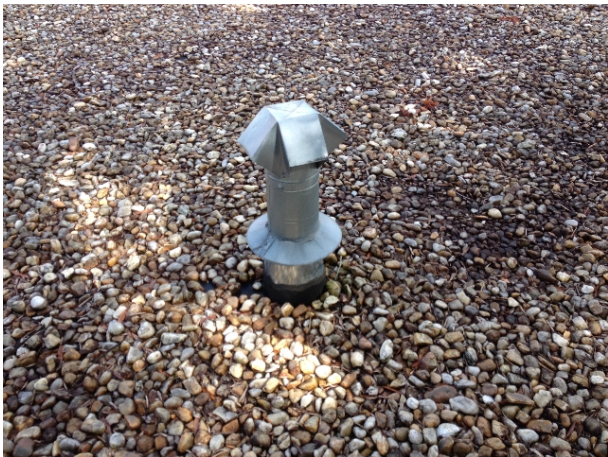
Typical roof vent

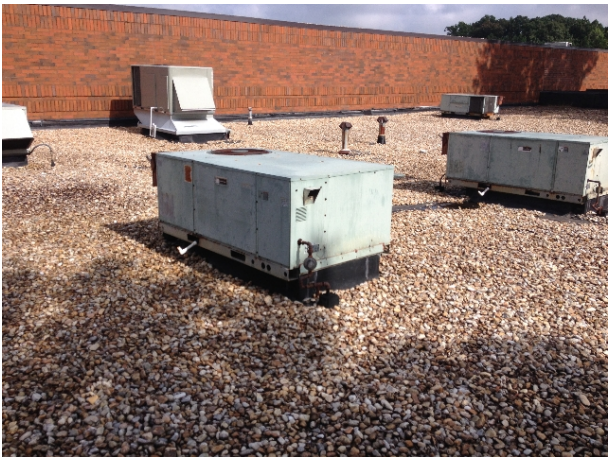
Typical HVAC unit

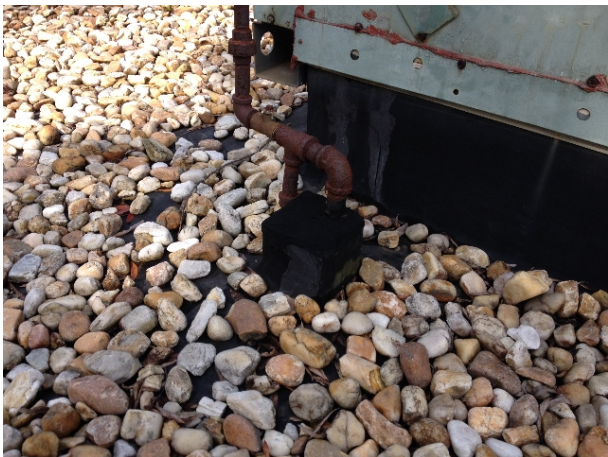
Typical pitch pan at HVAC unit

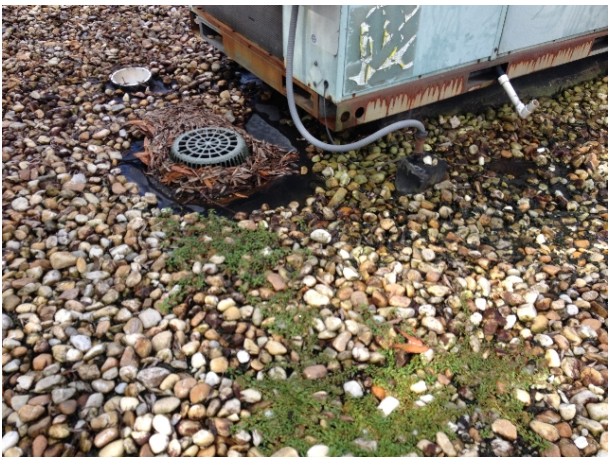
Drain and over flow drain pipe acting as drainage for roof (3 sets)

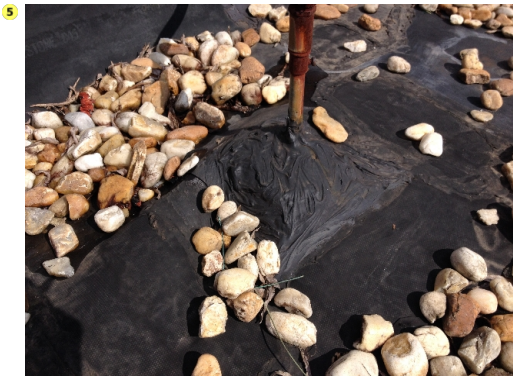
General - Improper Installation (Remedial)

The original installation of this detail was done improperly and not per industry standards.

Remove the existing detail and install a new detail per the industry and manufacturers recommendations and details.

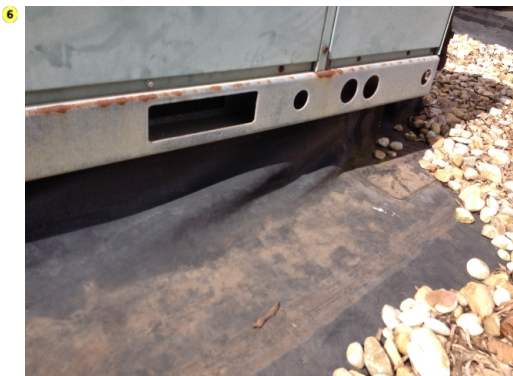
General - Tenting (Remedial)

Tenting of the membrane is caused by the overall shrinking that takes place over time. The shrinking of the membrane causing it to pull away from perimeter walls and cause stress of the flashing areas of the roof.

The existing membrane would need to be cut and allowed to relax and a new piece of flashing membrane spliced in to ensure a water tight seal.

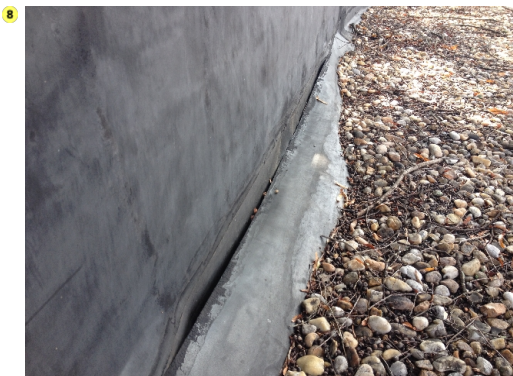
General - Splits (Remedial)

Splits in the membrane are typically due to building movement and lateral stress. As the membrane ages and weathers, it cannot withstand these forces and split open allowing water to enter the roof system.

The area surrounding the split must be cleaned. A new piece of waterproofing membrane would be installed and sealed per industry standards.

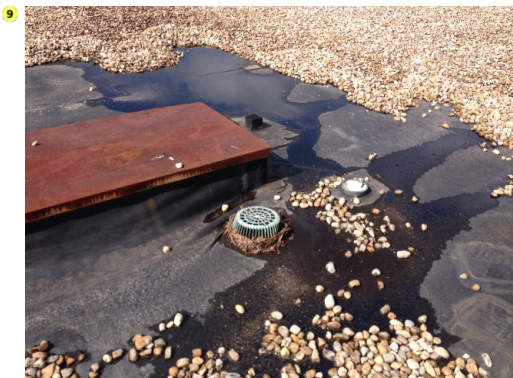
General - Oxidation or Rust (Remedial)

As the protective coating breaks down and the metal is exposed to the elements, oxidation or rust will take over and reduce the materials integrity.

Depending upon the level of corrosion, the metal may be able to be restored. In most cases the metal requires replacement.

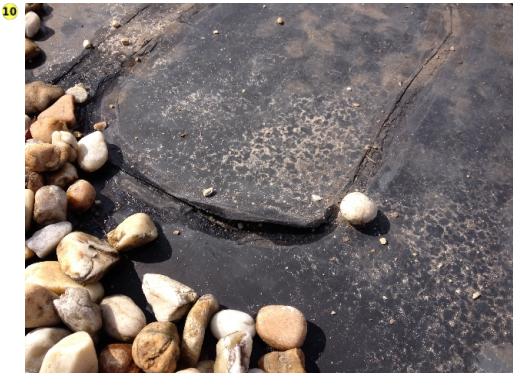
General - Open Seams (Remedial)

Open seams in the waterproofing membrane are typically caused by failing seam adhesives coupled with membrane shrinkage and stress on the seams.

The area surrounding the open seam must be cleaned. A new piece of waterproofing membrane would be installed and sealed per industry standards.

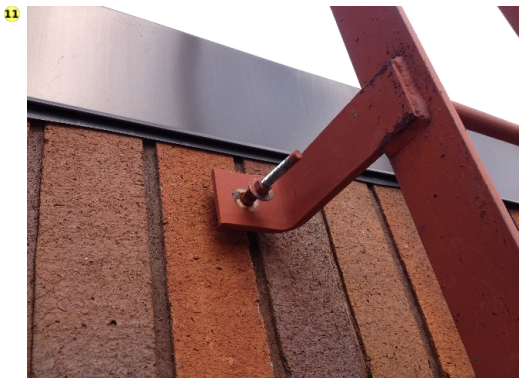
General - (Remedial)
Quantity: 1 EA
Deficiency:
Bolts on wall ladder are loose
Corrective Action:
Re-fasten bolts into wall

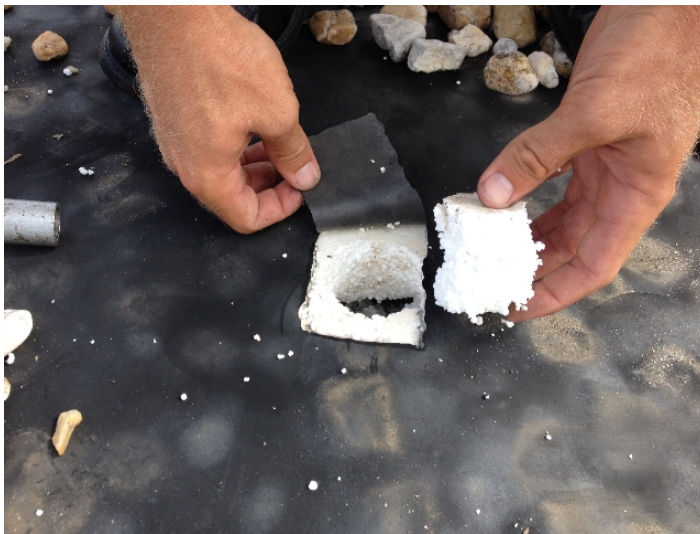
Test Cut 2
 EPDM-Ballast
 2" EPS
 Metal Deck

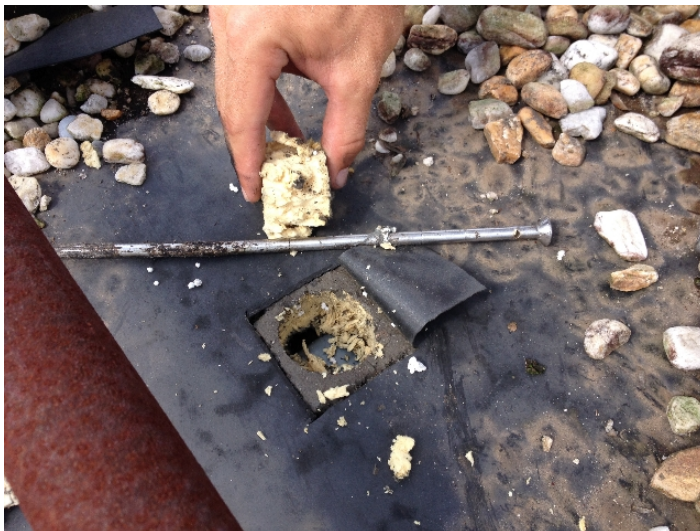
Test Cut 2 (New Extension)
 EPDM-Ballast
 1.5" PolyIso
 Metal Deck

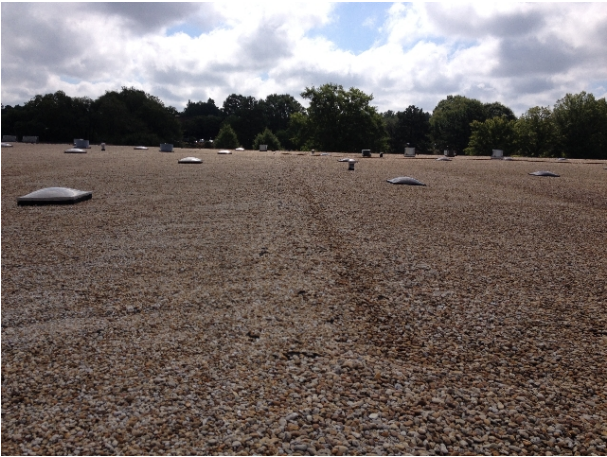
Overview at ridge line (at possible building expansion)

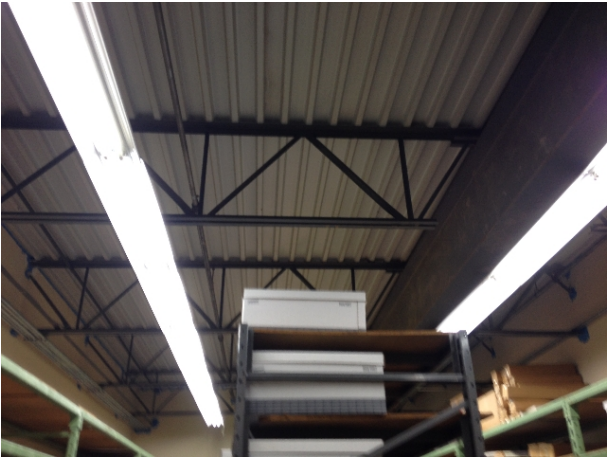
Photo of underneath side of decking

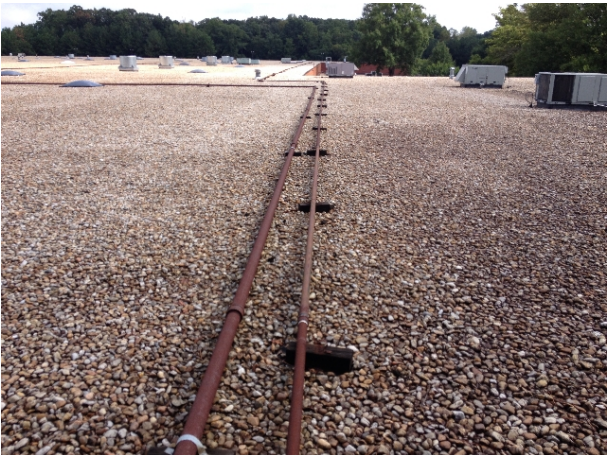
Rusted pipes on roof (recommend painting in future)

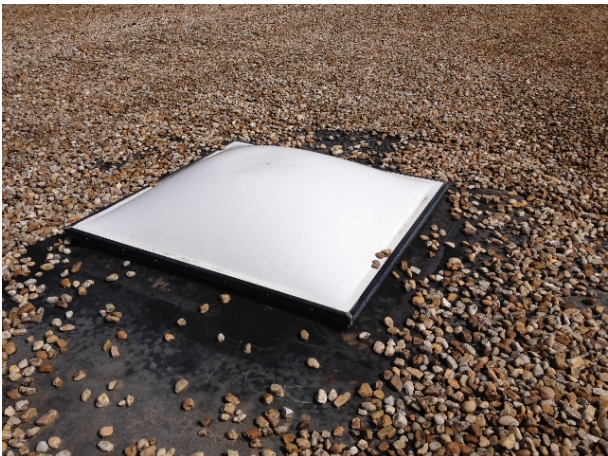
Skylight that is completely white

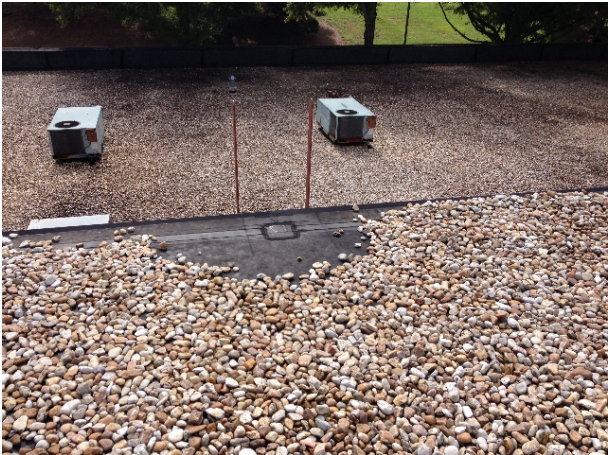
Ladder access to roof (needs walk pad)

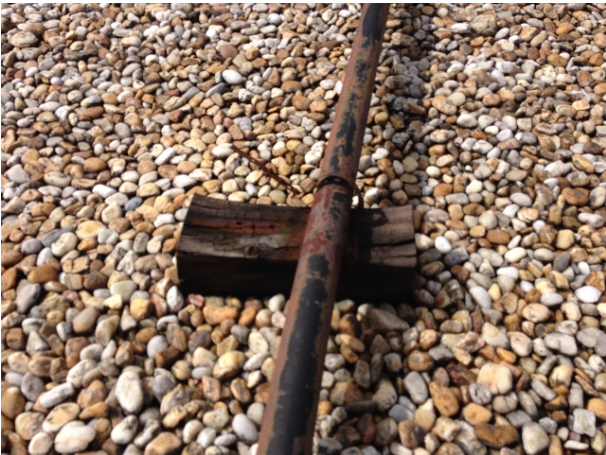
Wood blocking at pipes in bad condition (many are not fastened anymore)

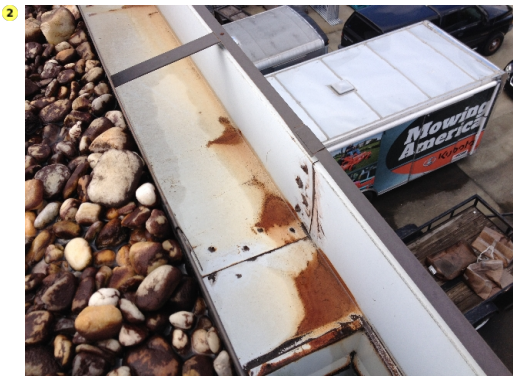
General - Oxidation or Rust (Remedial)

As the protective coating breaks down and the metal is exposed to the elements, oxidation or rust will take over and reduce the materials integrity.

Depending upon the level of corrosion, the metal may be able to be restored. In most cases the metal requires replacement.

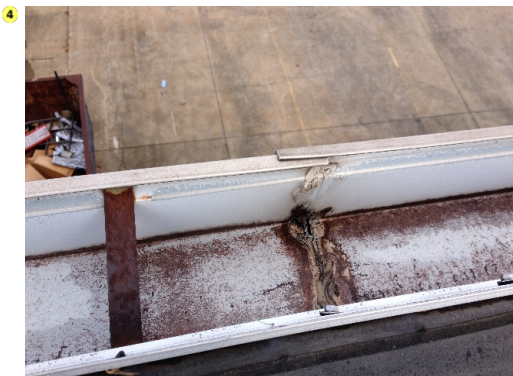
General - Oxidation or Rust (Remedial)

As the protective coating breaks down and the metal is exposed to the elements, oxidation or rust will take over and reduce the materials integrity.

Depending upon the level of corrosion, the metal may be able to be restored. In most cases the metal requires replacement.

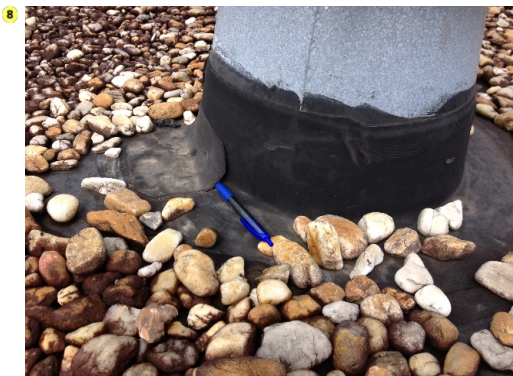
General - Open Flashing (Remedial)

Open flashings can be caused by membrane shrinkage, insufficient counterflashing or the simple aging and failure of the original flashing to remain adhered to the wall.

Depending on the severity of the deterioration of the flashing, they either will need to be removed completely and new flashing installed or the existing flashing must be re-sealed to the wall and the tops of the flashings covered up.

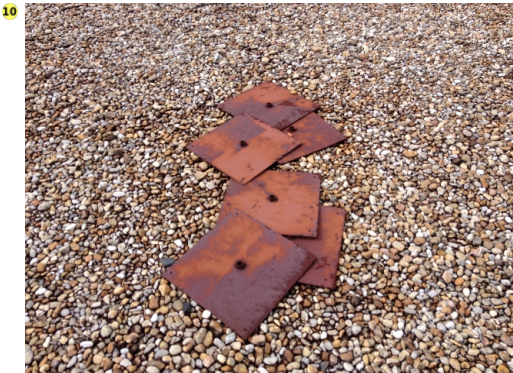
General - Loose Debris (Remedial)

Loose debris has a high probability of blowing around on the roof and causing damage to the waterproofing membrane.

Remove loose debris from roof area

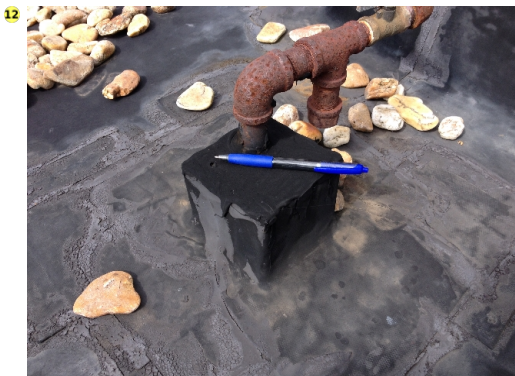
General - Failing Penetration (Remedial)

Due to overall age, weathering and UV the penetration has failed.

The penetration should be repaired/flashed per industry standards to ensure a water tight seal.

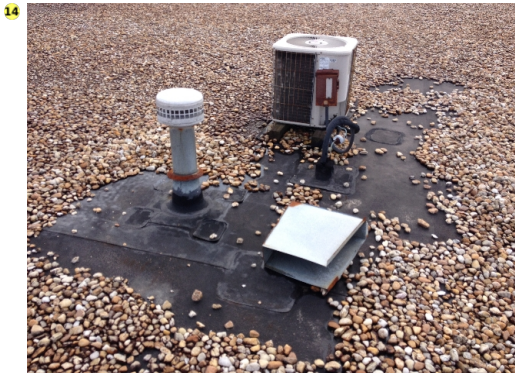
General - Loose Debris (Remedial)

Loose debris has a high probability of blowing around on the roof and causing damage to the waterproofing membrane.

Remove loose debris from roof area

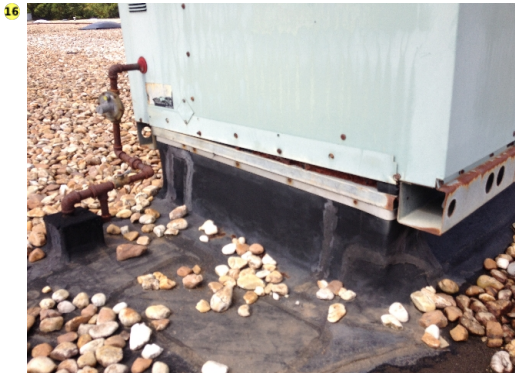
General - Improper Installation (Remedial)

The original installation of this detail was done improperly and not per industry standards.

Remove the existing detail and install a new detail per the industry and manufacturers recommendations and details.

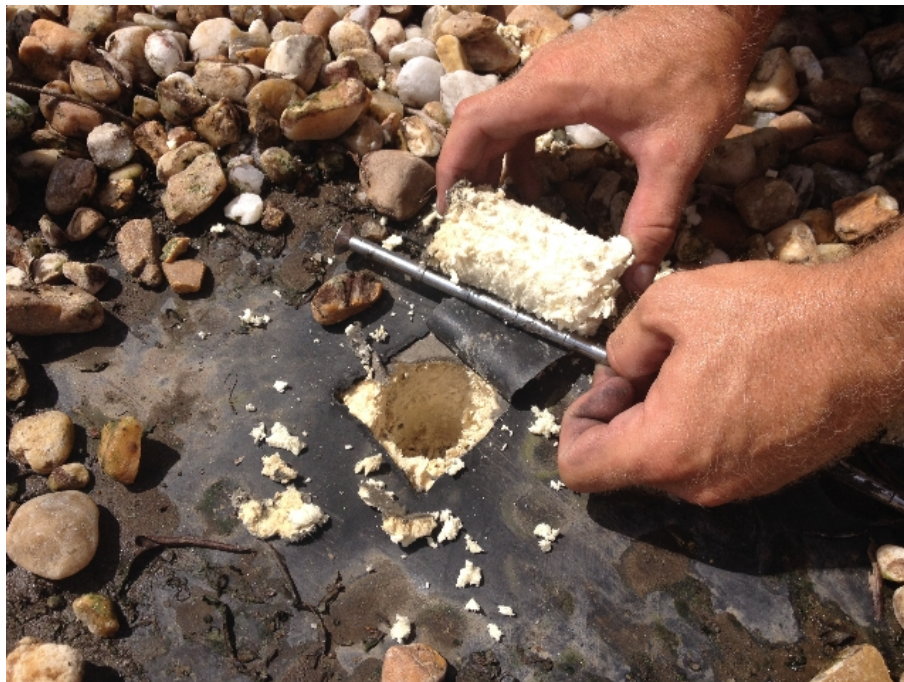
Test Cut 3
EDDM-Ballast
3.3" Polyiso
Metal Deck

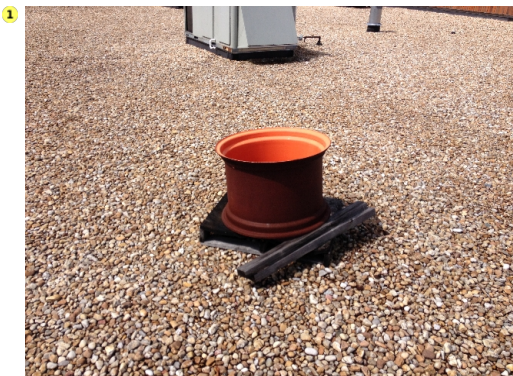
General - Loose Debris (Remedial)

Loose debris has a high probability of blowing around on the roof and causing damage to the waterproofing membrane.

Remove loose debris from roof area

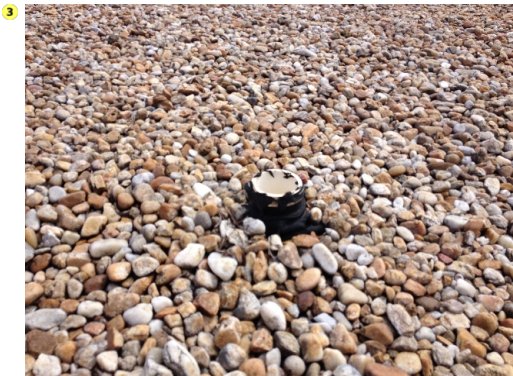
General - Improper Installation (Remedial)

The original installation of this detail was done improperly and not per industry standards.

Remove the existing detail and install a new detail per the industry and manufacturers recommendations and details.

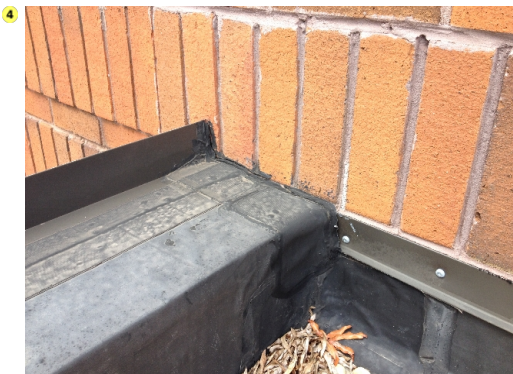
General - Open Flashing (Remedial)

Open flashings can be caused by membrane shrinkage, insufficient counterflashing or the simple aging and failure of the original flashing to remain adhered to the wall.

Depending on the severity of the deterioration of the flashing, they either will need to be removed completely and new flashing installed or the existing flashing must be re-sealed to the wall and the tops of the flashings covered up.

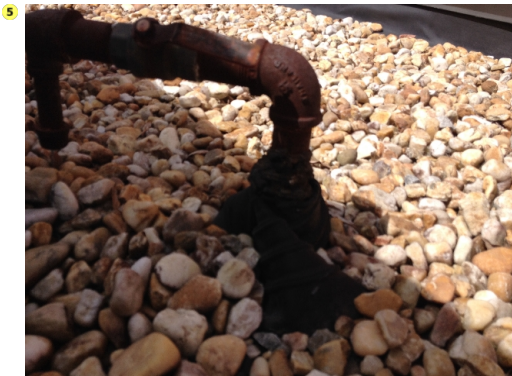
General - Improper Installation (Remedial)

The original installation of this detail was done improperly and not per industry standards.

Remove the existing detail and install a new detail per the industry and manufacturers recommendations and details.
