Management Report

Kubota Tractor Corp - Southeastern Division
Kubota Tractor Corp - Southeastern Division - Main Bldg
1025 Northbrook Parkway, Suwanee, GA

Prepared For
Kubota

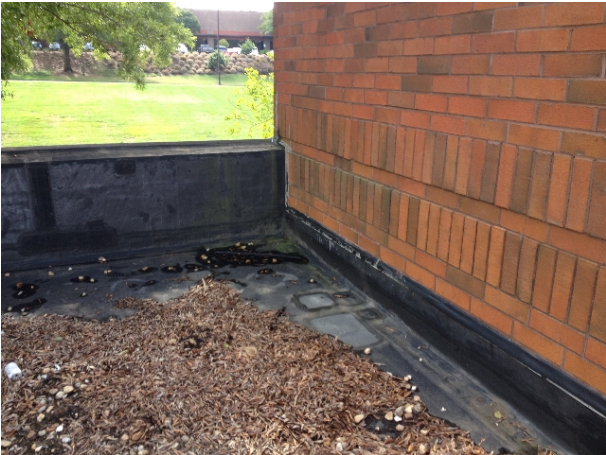
Corner of roof detail

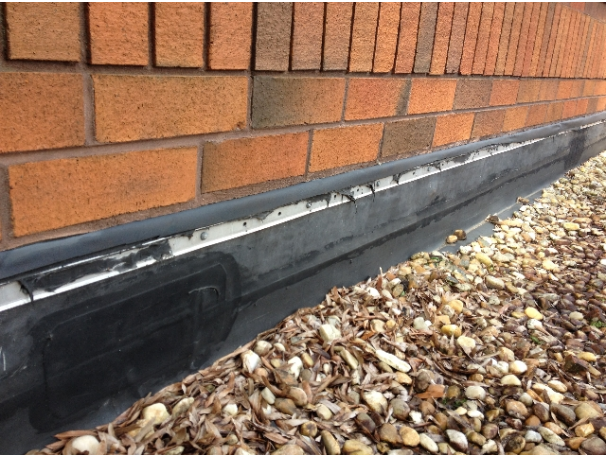
Termination bar detail at high walls

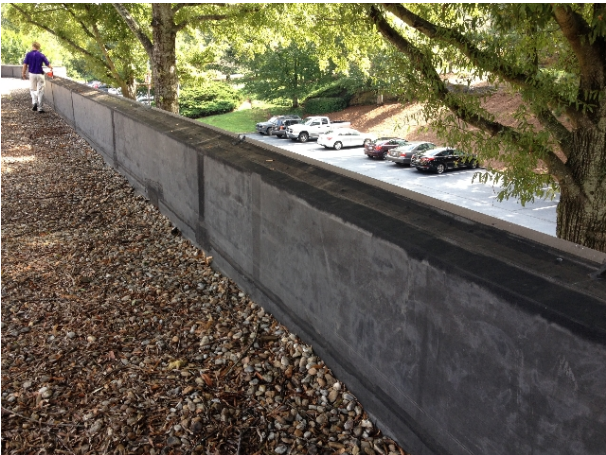
Outer parapet wall wrapped in membrane

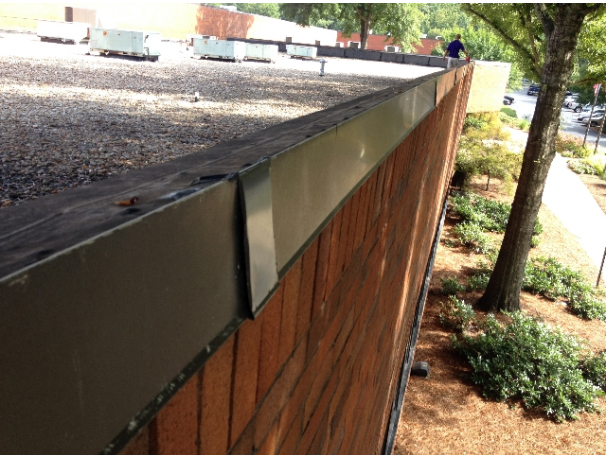
Gravel stop edge metal on parapet

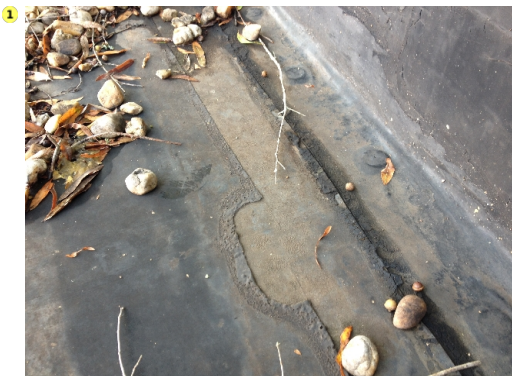
General - Open Seams (Remedial)

Open seams in the waterproofing membrane are typically caused by failing seam adhesives coupled with membrane shrinkage and stress on the seams.

The area surrounding the open seam must be cleaned. A new piece of waterproofing membrane would be installed and sealed per industry standards.

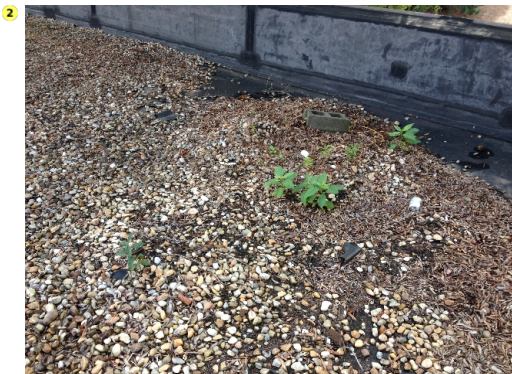
General - Organic Growth (Remedial)

This is a sign that a re-roof should be budgeted for. The area could also be spot replaced to remove the wet condition.

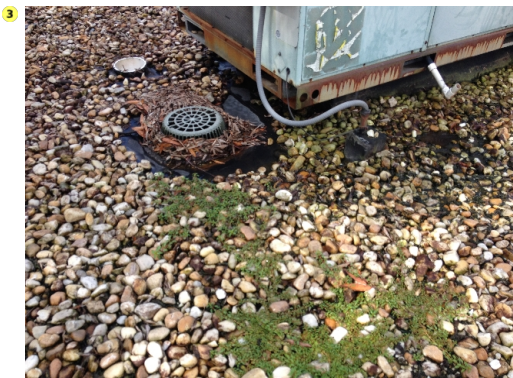
General - Clogged Scupper/Drain/Gutter (Remedial)

The scupper, drain, or gutter area must be cleaned and all debris removed to ensure water drains from the roof properly. This is to be part of a routine roof maintenance program.

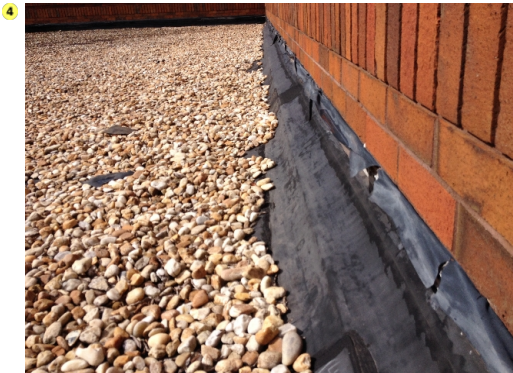
General - Tenting (Remedial)

Tenting of the membrane is caused by the overall shrinking that takes place over time. The shrinking of the membrane causing it to pull away from perimeter walls and cause stress of the flashing areas of the roof.

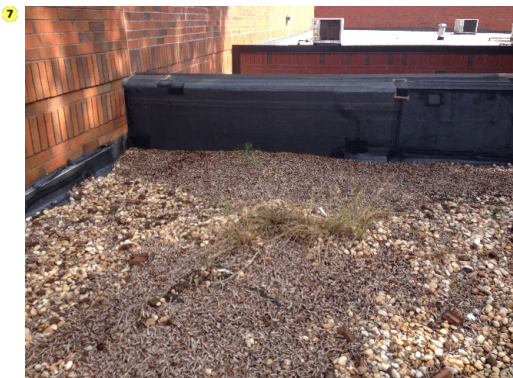
General - Organic Growth (Remedial)

This is a sign that a re-roof should be budgeted for. The area could also be spot replaced to remove the wet condition.

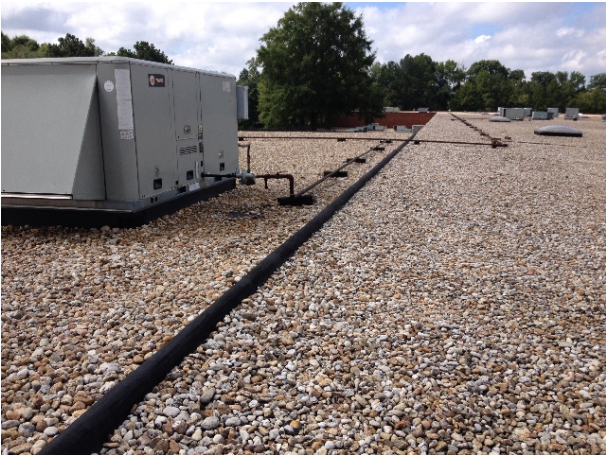
Expansion joint at front area

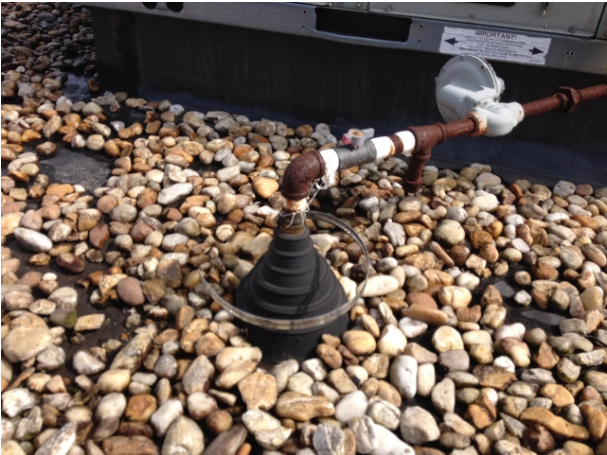
Typical pipe boot flashing at unit

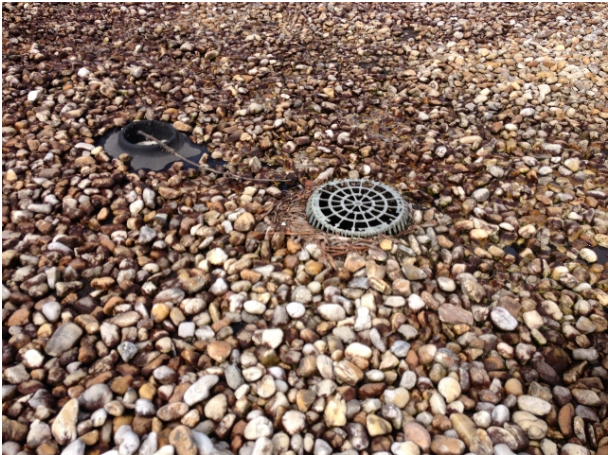
Drain and over flow drain

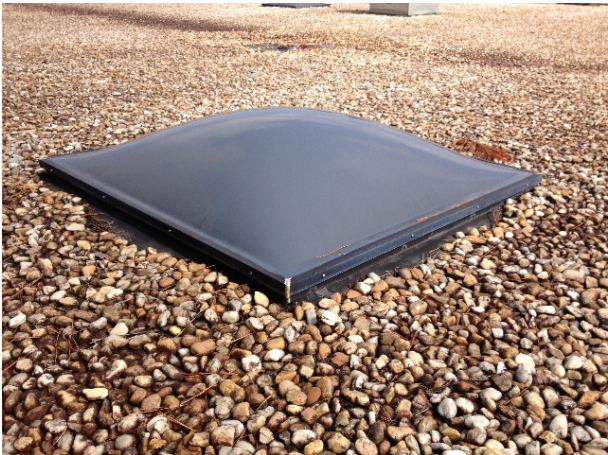
Skylight

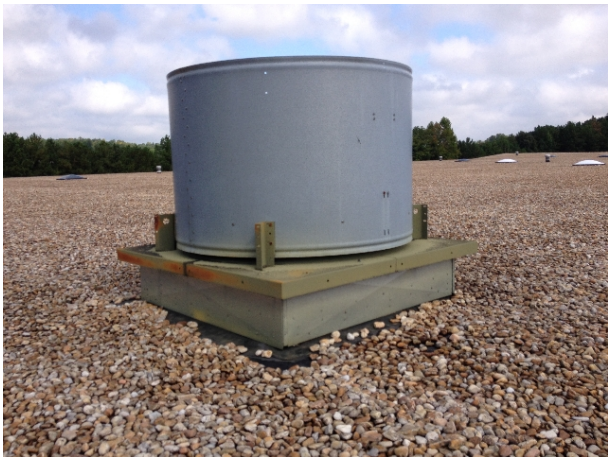
Typical fan on roof

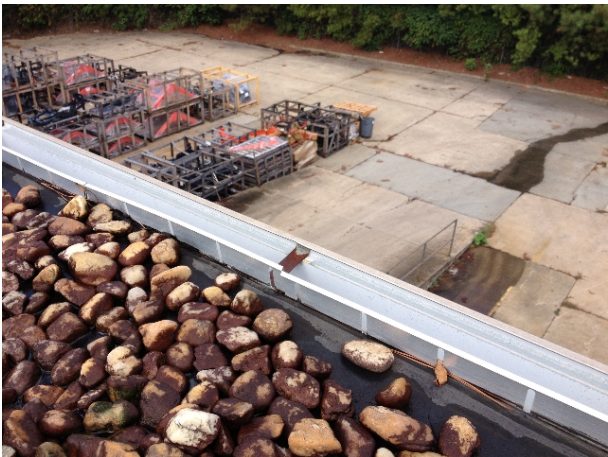
Gravel bar at gutter

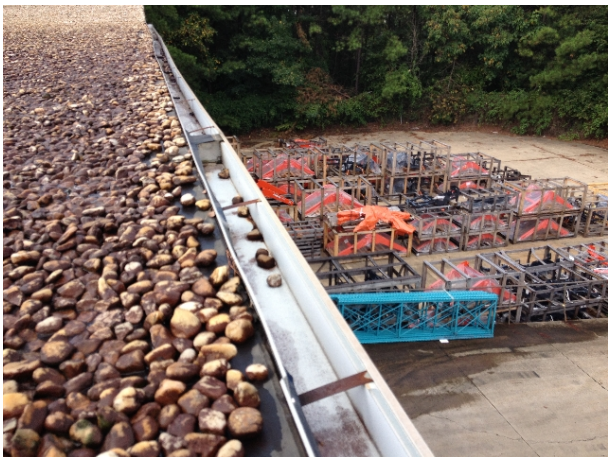
Gutter on back of building

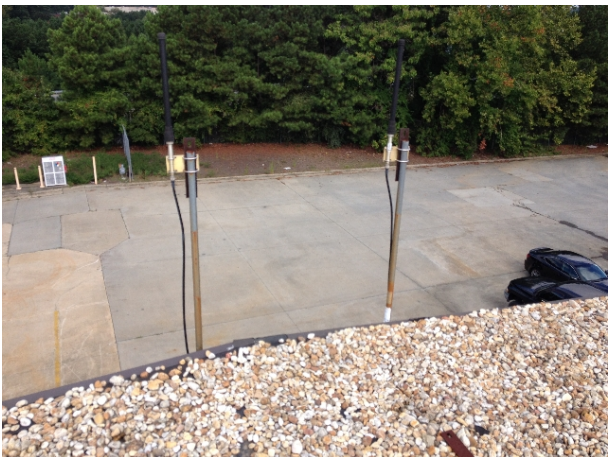
Antennas on back of building

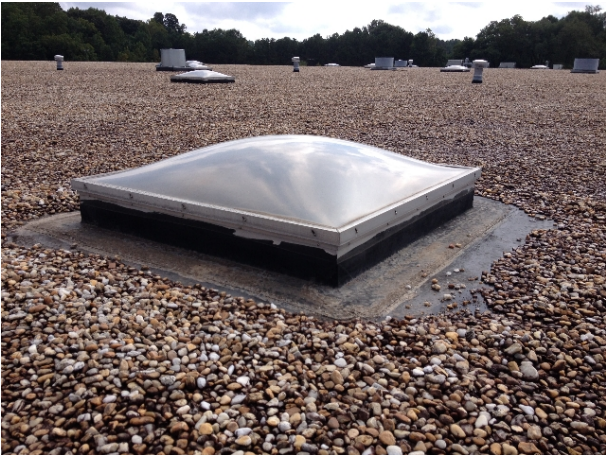
Another type of skylight

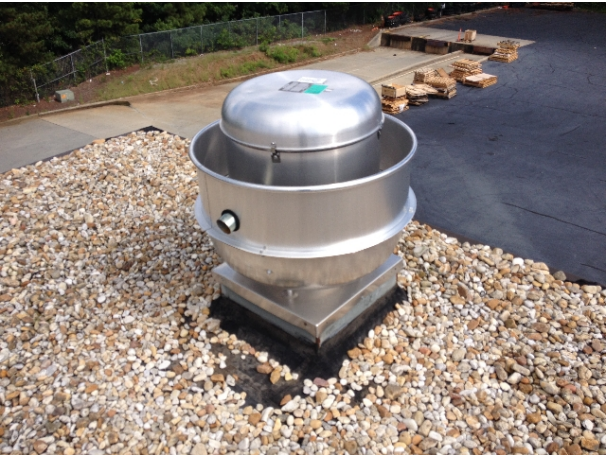
Typical vent/fan

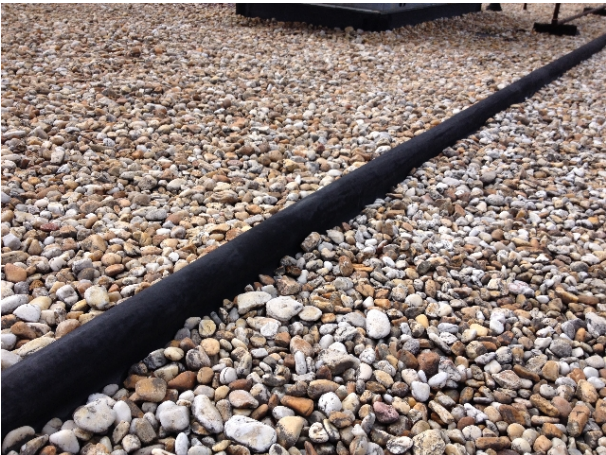
Close up of expansion joint

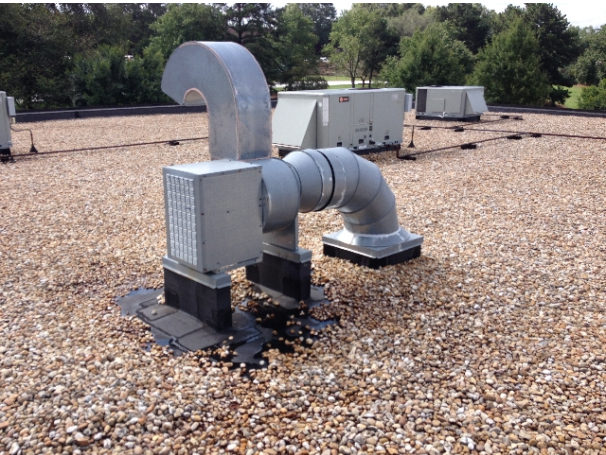
System mount on roof

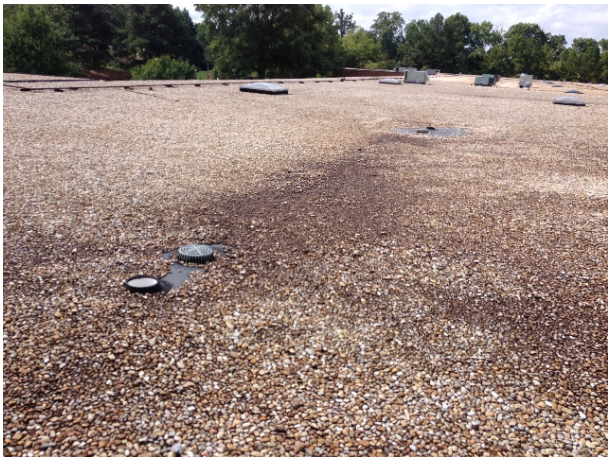
Overview of drain line

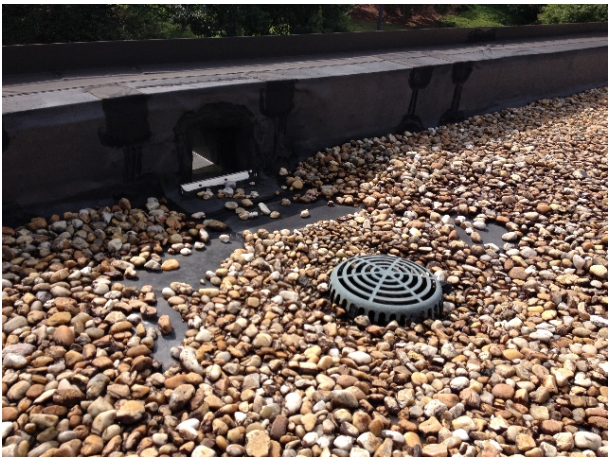
Photo of front wall wrapped with drain and scupper

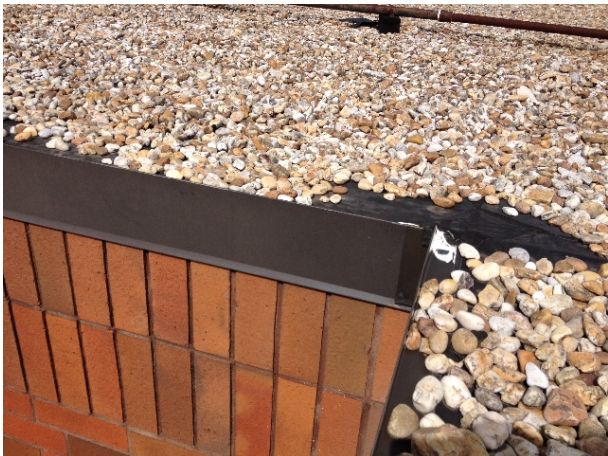
Gravel stop detail at perimeter

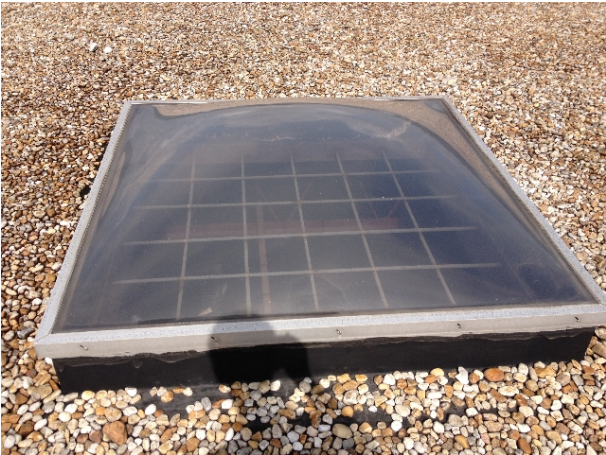
Safety/burglar bars mounted on inside of skylight

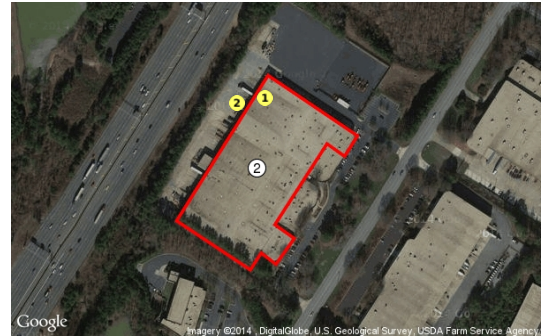
General - Open Seams (Remedial)

Open seams in the waterproofing membrane are typically caused by failing seam adhesives coupled with membrane shrinkage and stress on the seams.

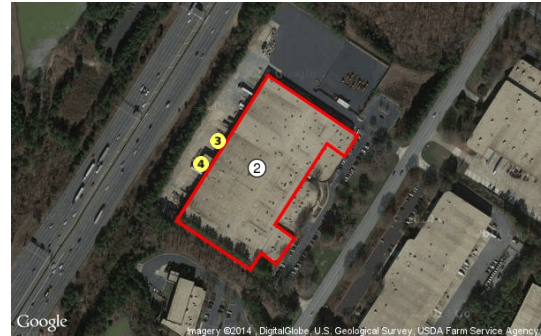
General - Ponding (Remedial)

A ponding water condition is typically due to a flaw in how the original roof was designed to flow to drains or the underlying insulation has collapsed due to age or weight and created a low lying area on the roof which is now holding water.

A ponding water condition is best corrected during a re-roof project. Outside of removing the existing insulation and starting with a new roof design, ponding water is difficult to correct.

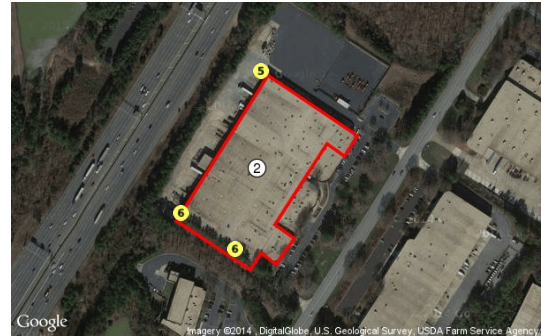
General - Open Flashing (Remedial)

Open flashings can be caused by membrane shrinkage, insufficient counterflashing or the simple aging and failure of the original flashing to remain adhered to the wall.

Depending on the severity of the deterioration of the flashing, they either will need to be removed completely and new flashing installed or the existing flashing must be re-sealed to the wall and the tops of the flashings covered up.

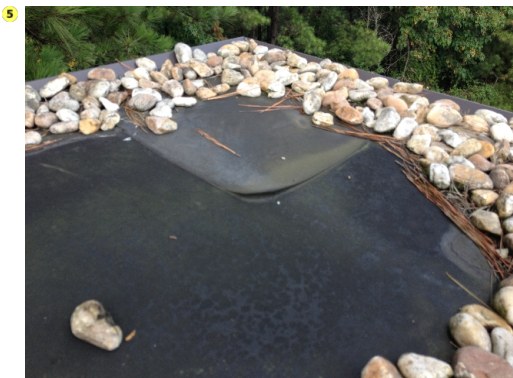
Deficiency:

This is a sign that a re-roof should be budgeted for. The area could also be spot replaced to remove the wet condition.

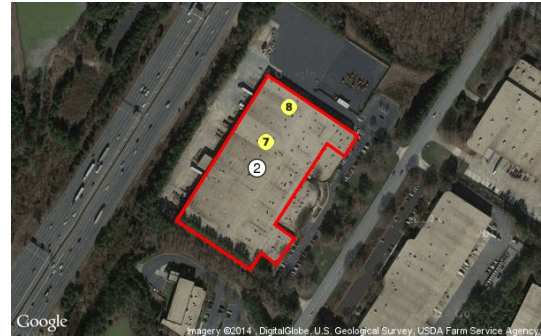
General - Ponding (Remedial)

A ponding water condition is typically due to a flaw in how the original roof was designed to flow to drains or the underlying insulation has collapsed due to age or weight and created a low lying area on the roof which is now holding water.

A ponding water condition is best corrected during a re-roof project. Outside of removing the existing insulation and starting with a new roof design, ponding water is difficult to correct.

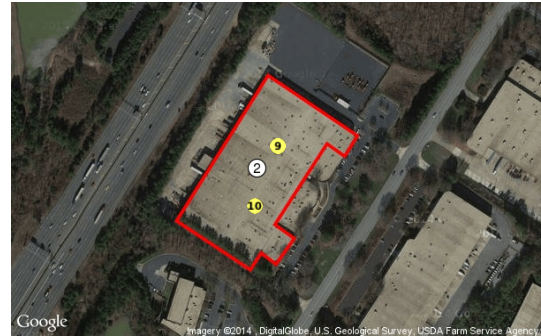
General - Ballast Displacement (Remedial)

Ballast displacement causes the roof to experience unnecessary stretching/bridging due to improper weight distribution. It will also make the roof more susceptible to wind uplift as the area is not weighted down adequately.

Repair any bridging an/or damage to roofing membrane and replace rock as per roofing uplift code specifications for the geographical zone.

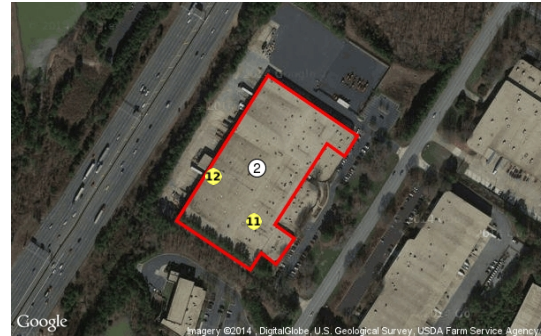
General - Ballast Displacement (Remedial)

Ballast displacement causes the roof to experience unnecessary stretching/bridging due to improper weight distribution. It will also make the roof more susceptible to wind uplift as the area is not weighted down adequately.

Repair any bridging an/or damage to roofing membrane and replace rock as per roofing uplift code specifications for the geographical zone.

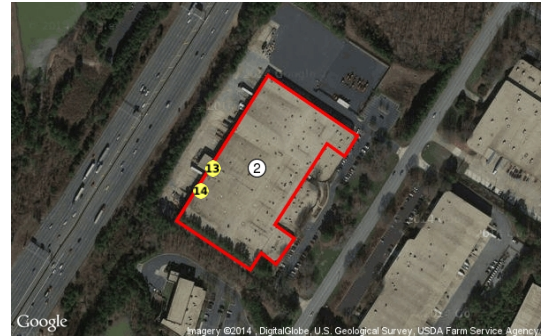
General - Open Flashing (Remedial)

Open flashings can be caused by membrane shrinkage, insufficient counterflashing or the simple aging and failure of the original flashing to remain adhered to the wall.

Depending on the severity of the deterioration of the flashing, they either will need to be removed completely and new flashing installed or the existing flashing must be re-sealed to the wall and the tops of the flashings covered up.

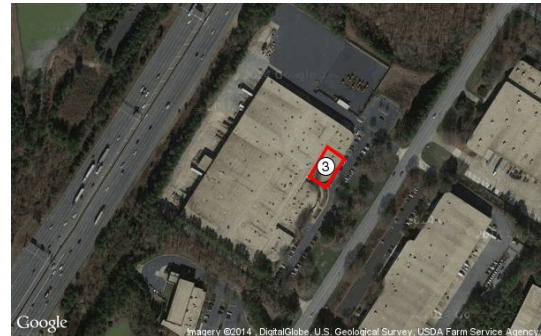
Test Cut 3
EDDM-Ballast
3.3" Polyiso
Metal Deck

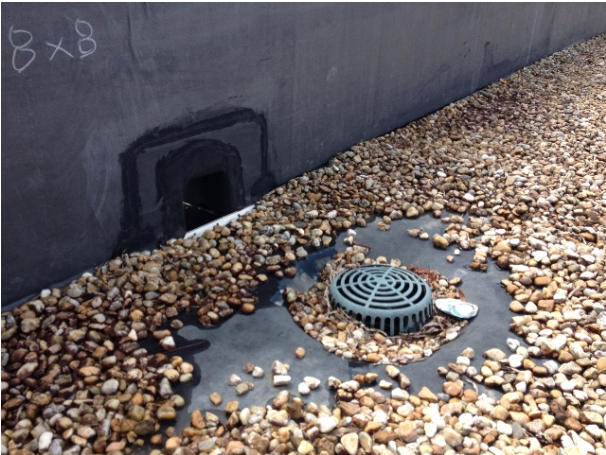
Drain and scupper detail

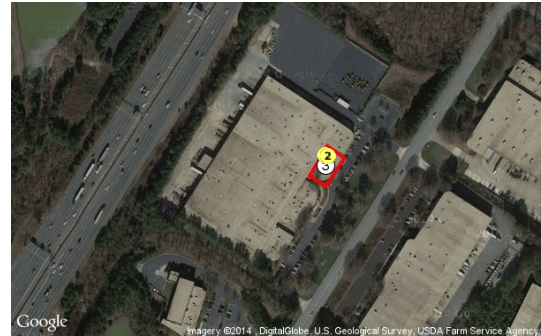
General - Loose Debris (Remedial)

Loose debris has a high probability of blowing around on the roof and causing damage to the waterproofing membrane.

Remove loose debris from roof area

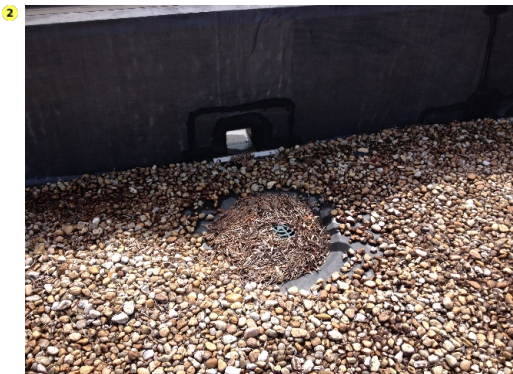
General - Clogged Scupper/Drain/Gutter (Remedial)

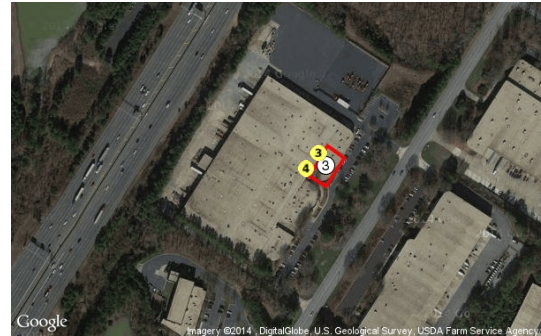
General - Improper Installation (Remedial)

The original installation of this detail was done improperly and not per industry standards.

Remove the existing detail and install a new detail per the industry and manufacturers recommendations and details.

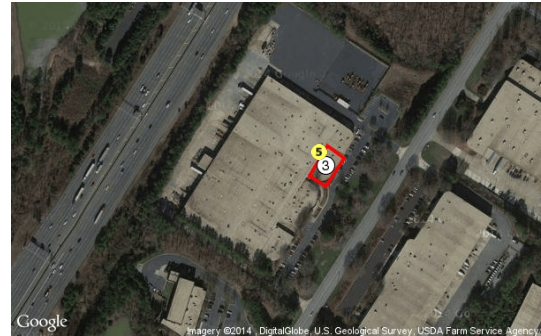
General - Improper Installation (Remedial)

The original installation of this detail was done improperly and not per industry standards.

Remove the existing detail and install a new detail per the industry and manufacturers recommendations and details.
